Addendum to Phase I
Environmental Site
Assessment
Partner Engineering

**Subject: Addendum to Phase I Environmental Site Assessment
Vacant Land – Summary of Hydraulic Lift Removal Activities**
Southwest Corner of Monroe Street and 42nd Avenue
Indio, California 92203
Partner Project No. 22-388815.2

SUBSURFACE INVESTIGATION TO LOCATE UNDERGROUND UTILITIES

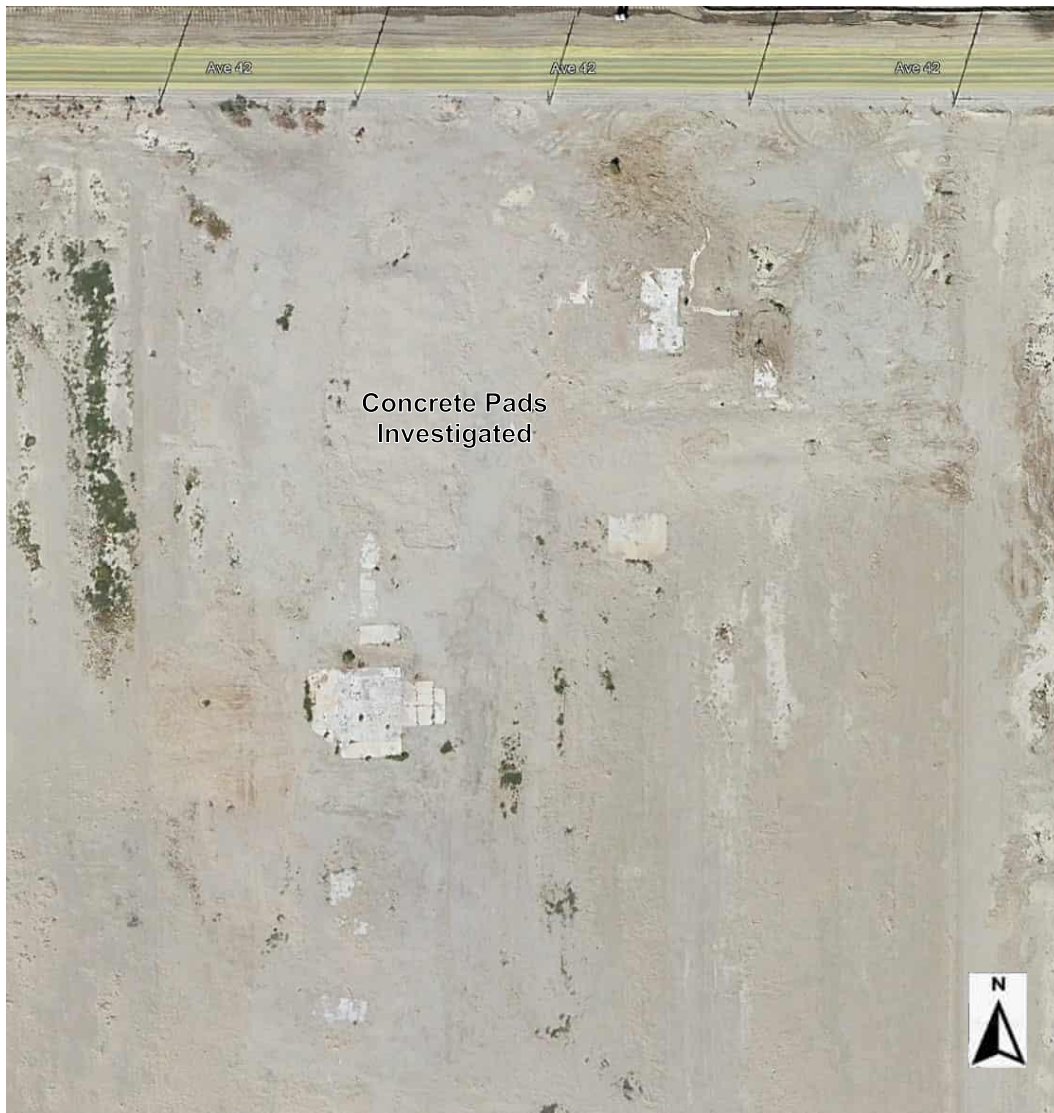
Figure 2. Site/Areas of Interest

SoCal Locators to perform a "Subsurface Investigation", using electromagnetic and ground penetrating radar (GPR) equipment in an attempt to evaluate if there USTs or any other subsurface obstructions in concrete areas. Located utilities are to be delineated with APWA color coded marking paint. Found anomalies with GPR will be delineated using white APWA marking paint.

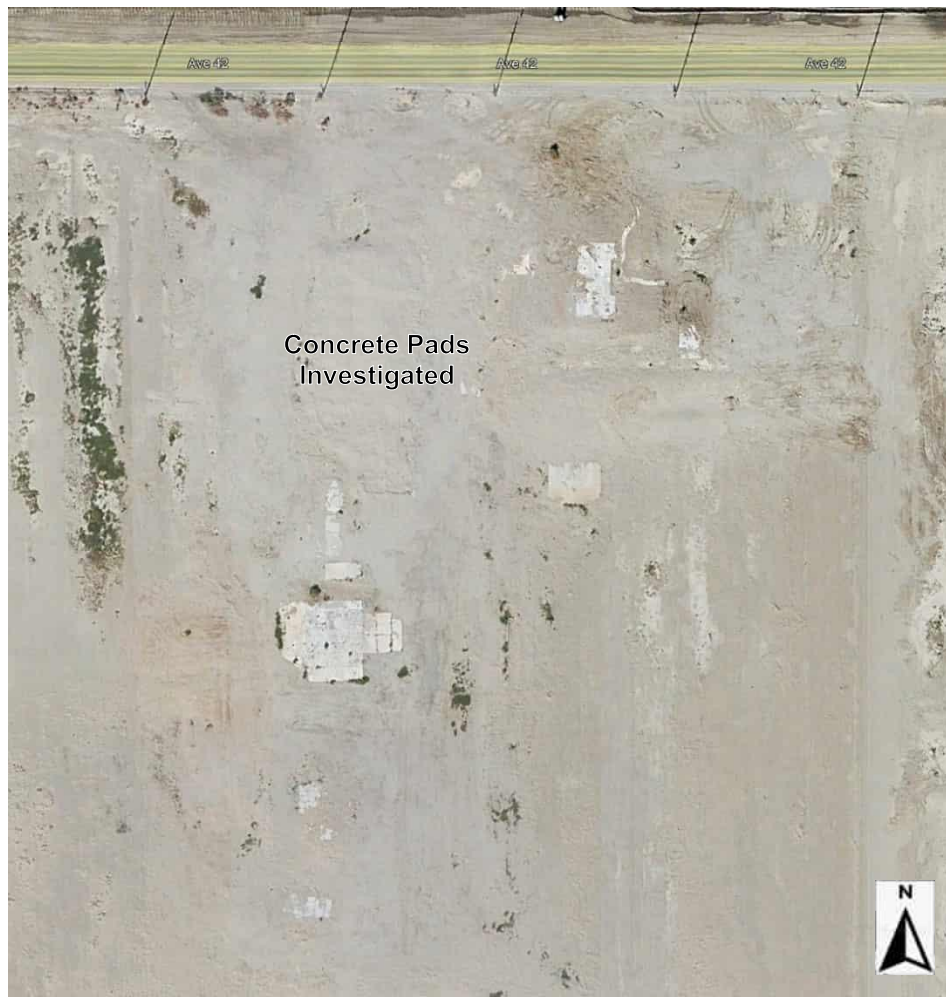
Figure 3. – Area scanned

Our technician performed a subsurface investigation using Electro Magnetics and GPR to locate all known utilities in the provided project area to evaluate if there are USTs or any other subsurface obstructions in concrete areas. All found utilities were delineated using APWA color coded marking paint. All found anomalies using GPR were delineated using white marking paint.

Evaluated a total of (12) concrete pads. Also evaluated (1) concrete pad outside designated scope. Informed Mya about find and ran GPR.

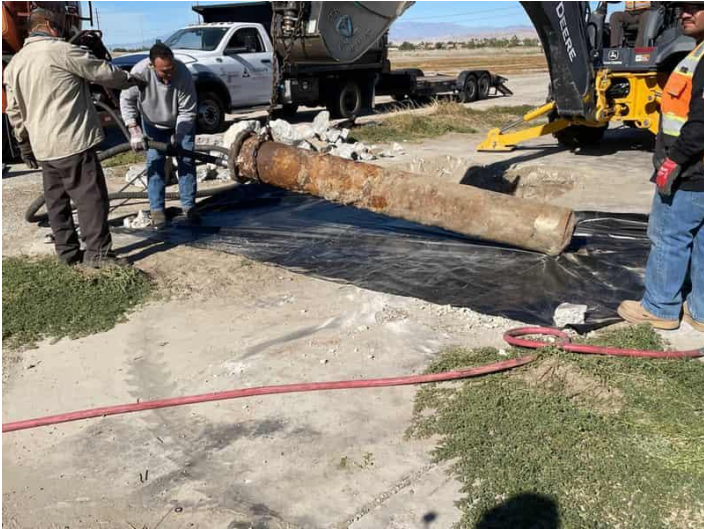
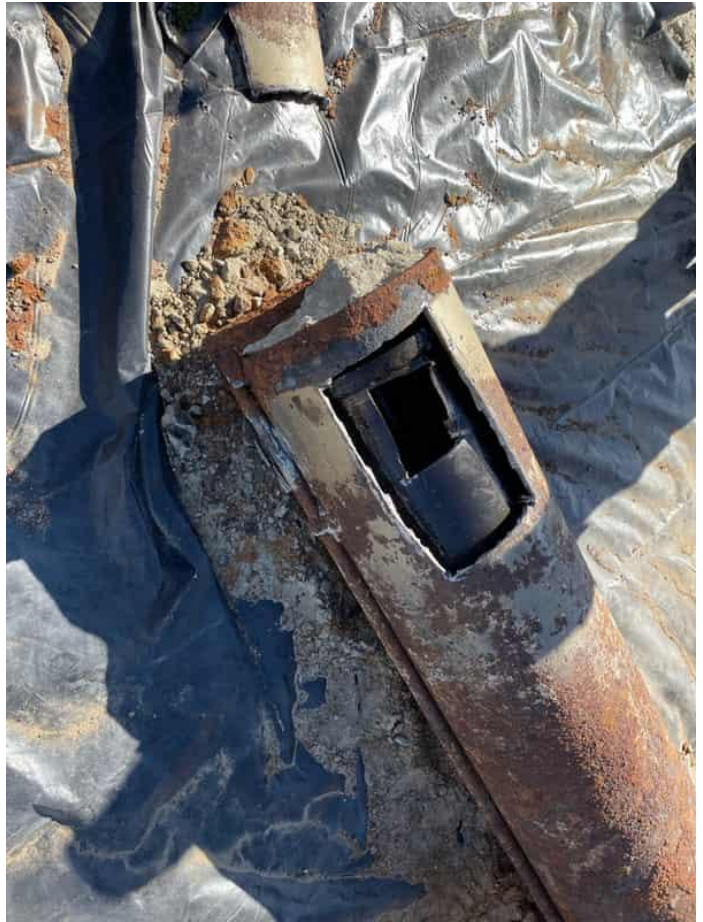
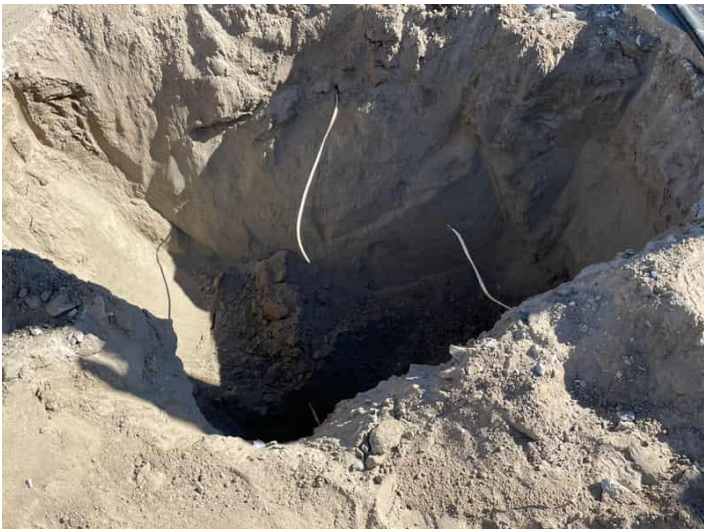
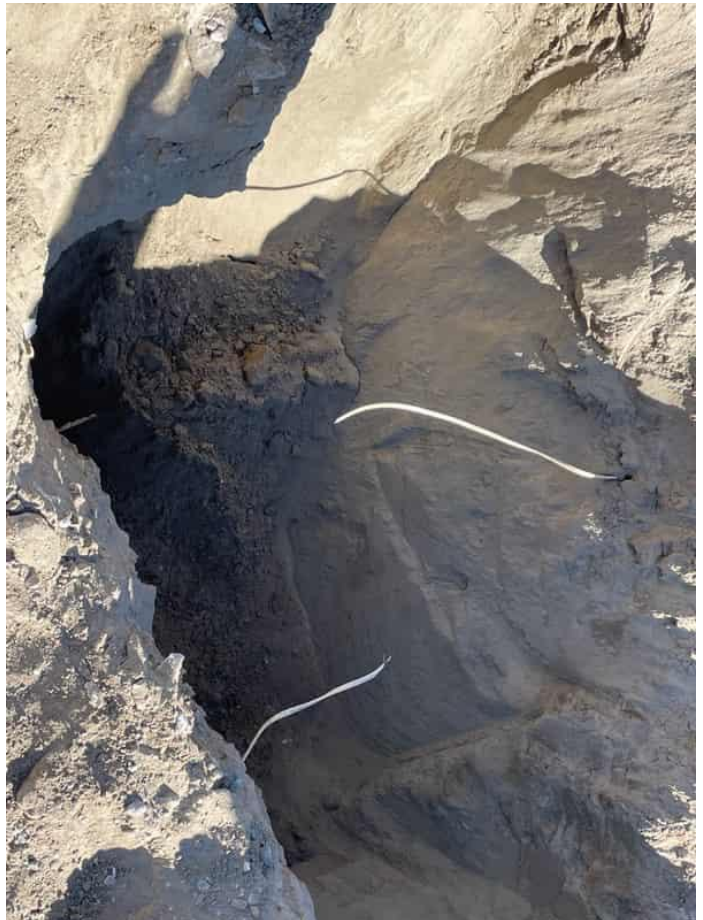
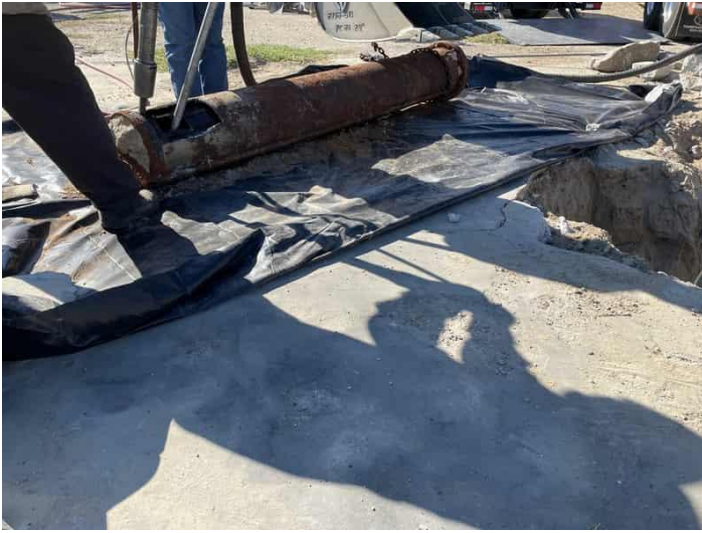
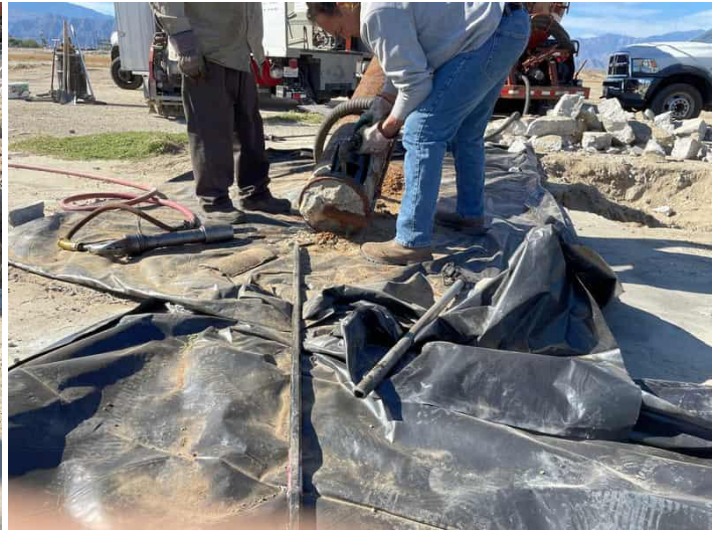
Photo Description

Areas of Work Being Observed: Hydraulic piston and concrete pads throughout site

- One unknown utility is found to the north of the hydraulic piston
 08:10 - StrongArm is cleared to begin breaking concrete around piston. SoCal Locators moved to scan other concrete pads south of piston

08:35 - Stop excavating because the excavator began leaking hydraulic fluid
 - laid out plastic beneath excavator to catch any liquid
 - Called repair company to come out and fix the leaking piece

09:48 - Attach vacuum truck to piston. Going to pump about 90% of the fluid out before removing the lift to reduce spillage during the removal
 - Repair man on site

09:35 - Excavator repaired and being excavating around the piston
 10:15 - SoCal locators found an additional concrete pad on the northeast portion of the property

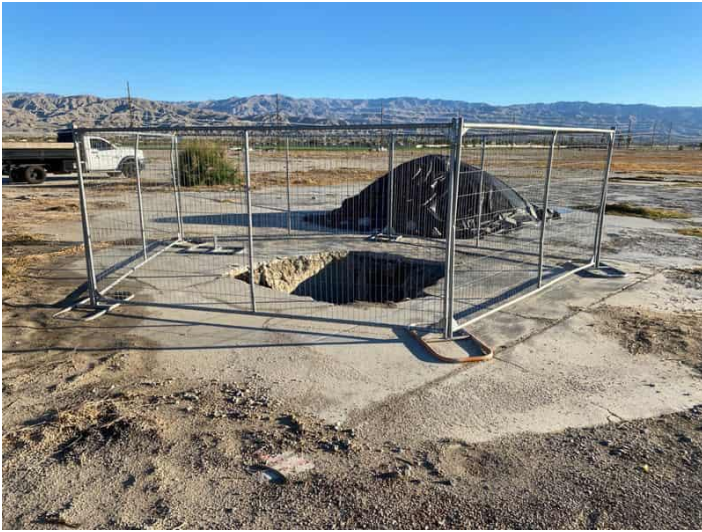
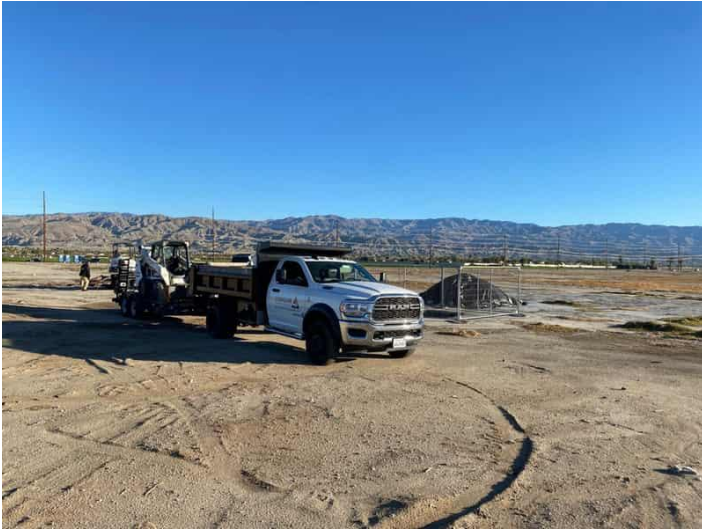
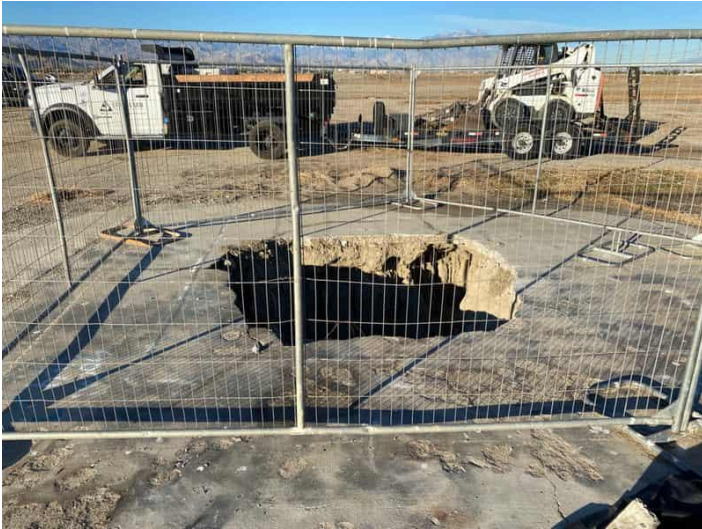
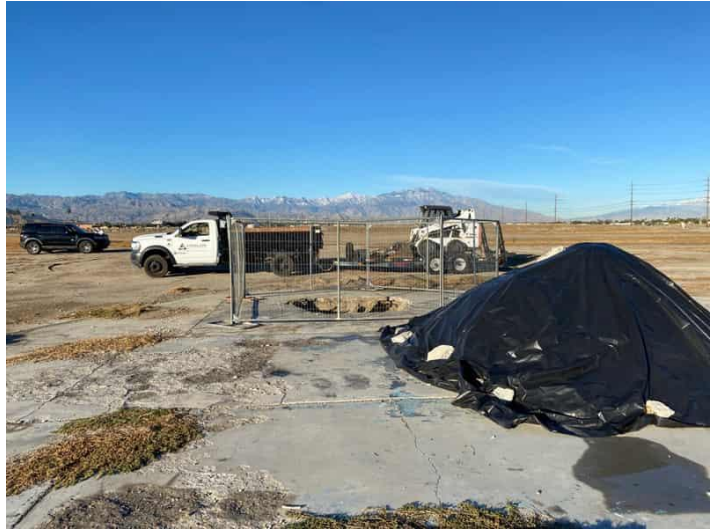
Photo Document of General On-Site Activities - 1. Piston Removal Site Pre-Backfill Activities

Piston Removal Site Pre-Backfill Activities

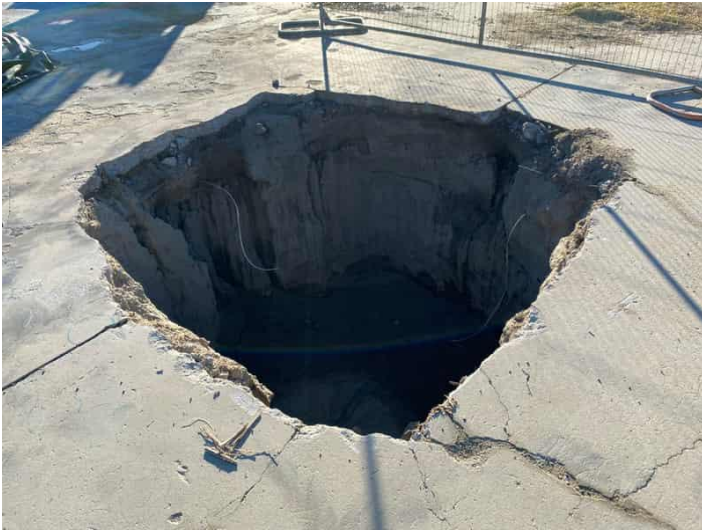
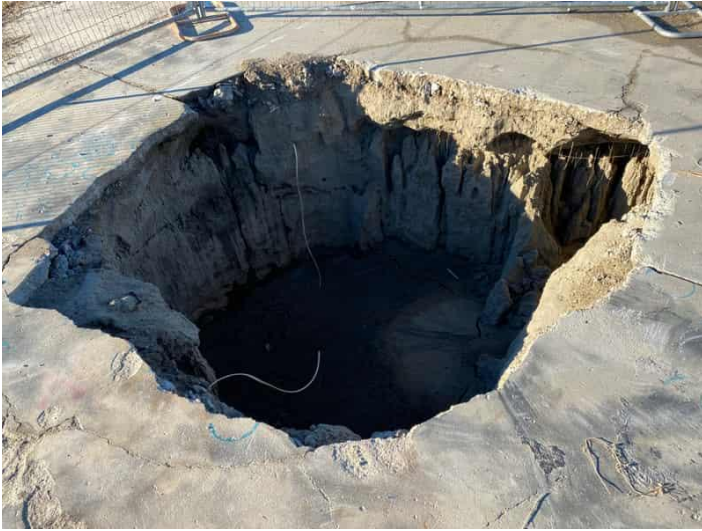
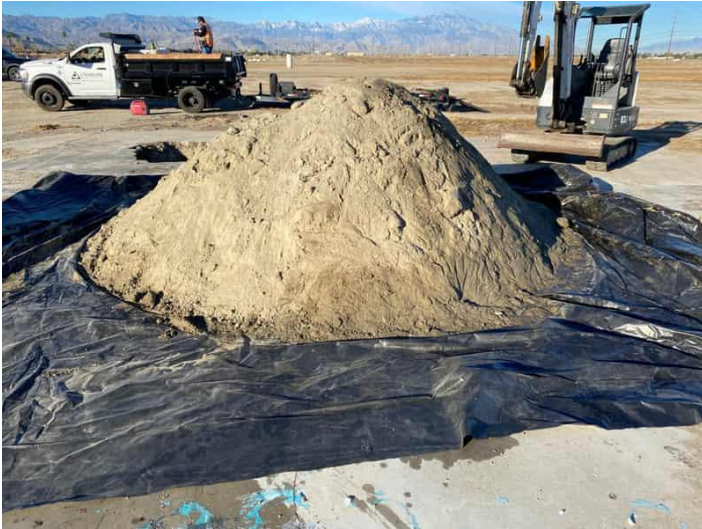
Piston Excavation Pit and Soil Pre-Backfill Activities

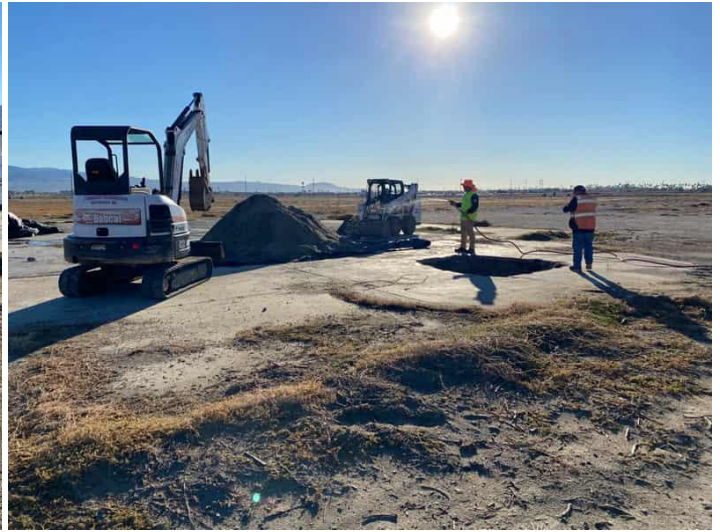
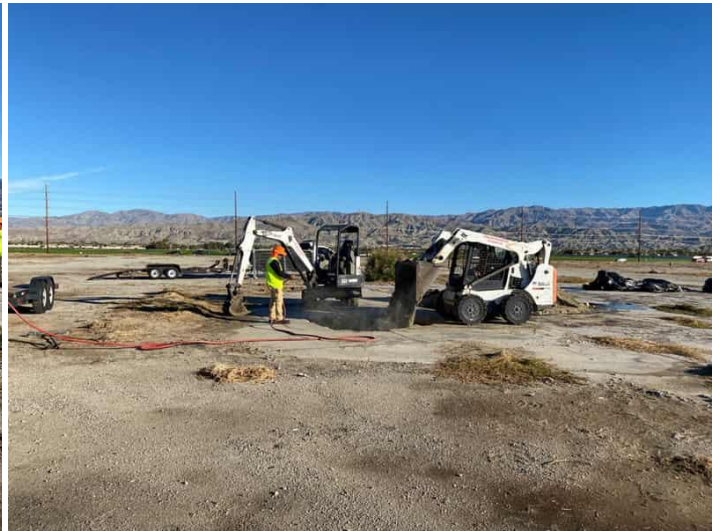
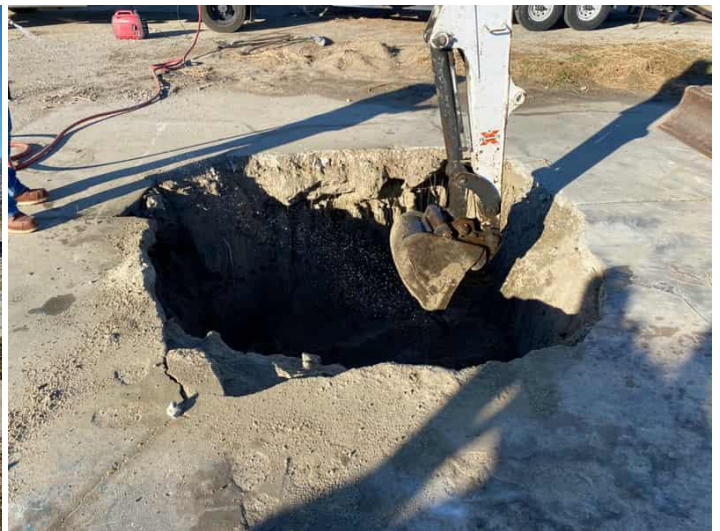
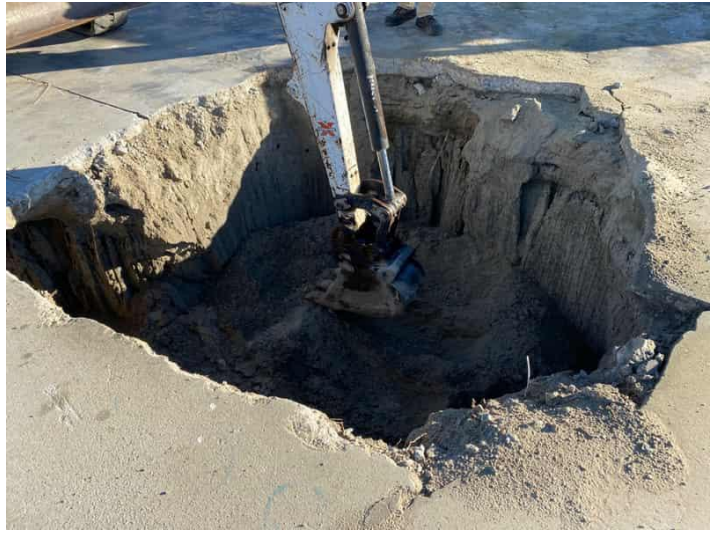
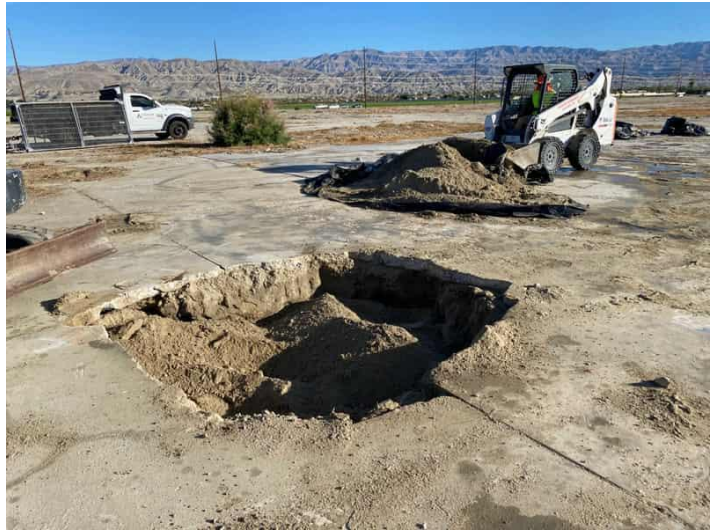
Photo Document of General On-Site Activities - 3. Piston Excavation Pit Backfill and Compacting Activities

Piston Excavation Pit Backfill and Compacting Activities

8:35 AM- Strongarm began backfilling activities. 1) water down soils 2) grab some soil from stockpile and dump into pit 3) compact soil with bobcat equipment arms 4) repeat until Piston Excavation Pit was full

9:26 AM- Strongarm completed backfilling of the Piston Excavation Pit and began compacting activities by driving over the filled pit eight times
 9:28 AM- Compacting activities were finished and walked over to Anomaly site to observe and determine location

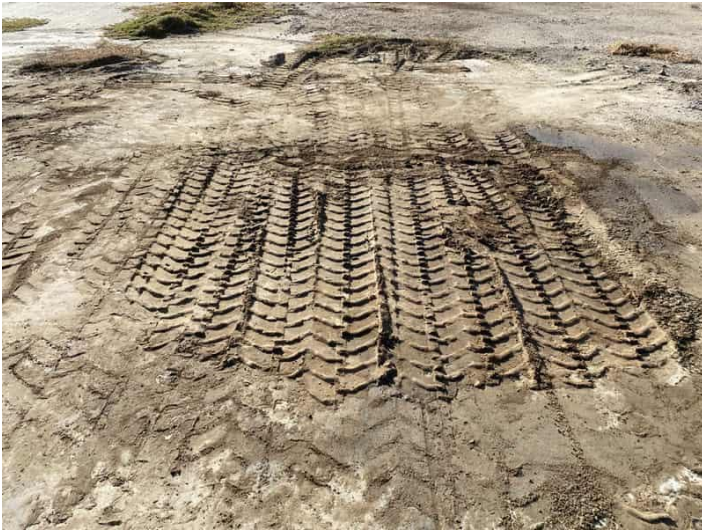
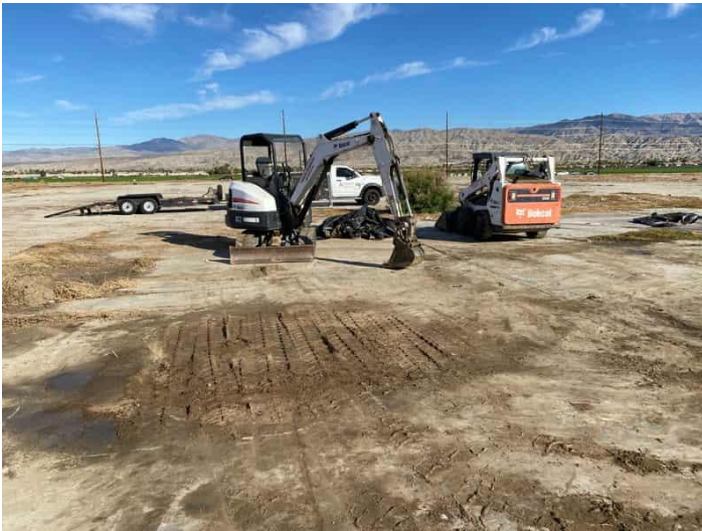
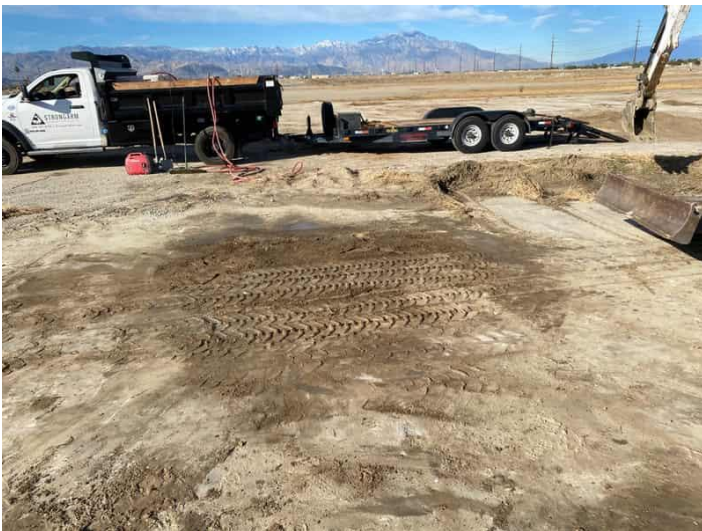
Final View of Piston Excavation Pit Post-Backfill and Compact

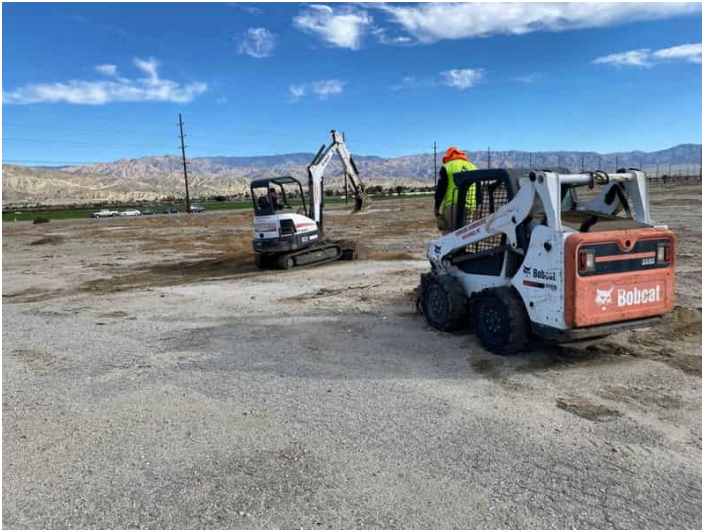
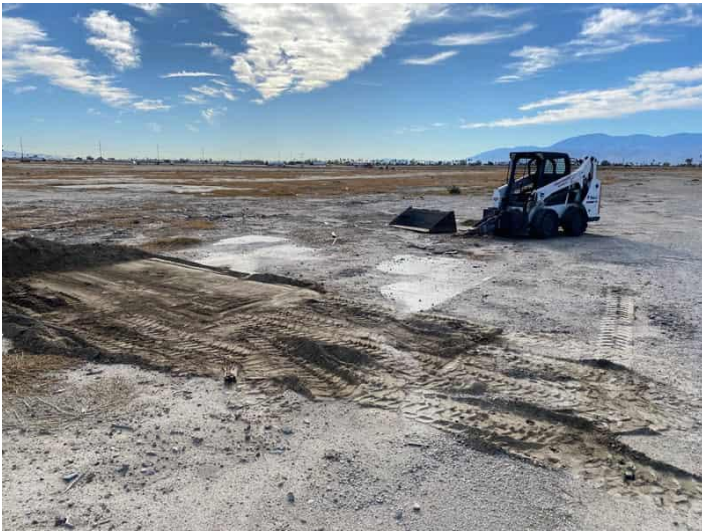
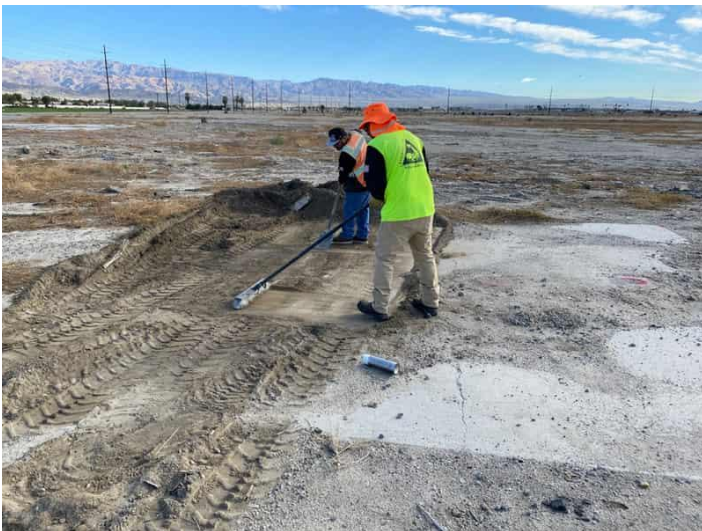
Photo Document of General On-Site Activities - 6. Anomaly Site Excavation Activities

Photo Description | Anomaly Site Pre-Excavation Activities

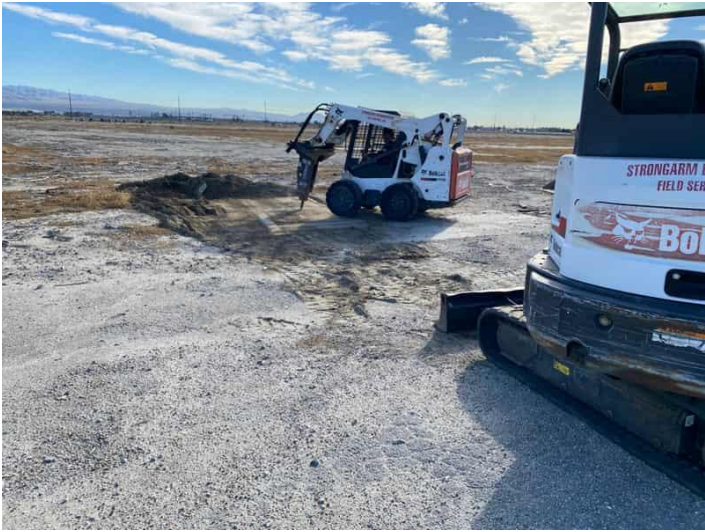
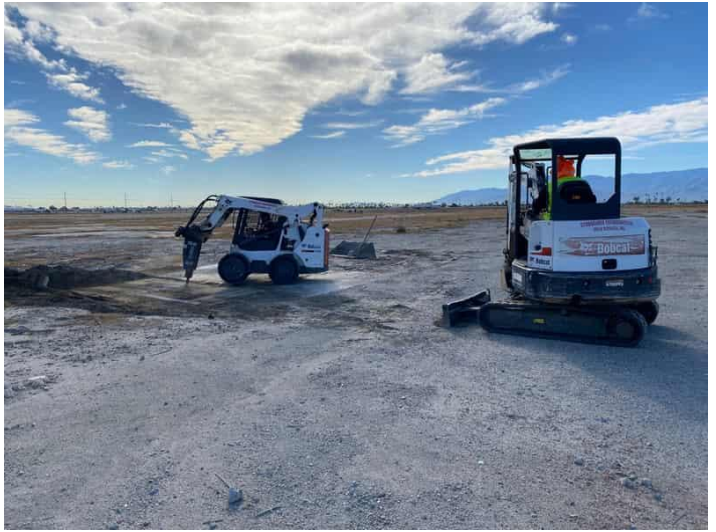
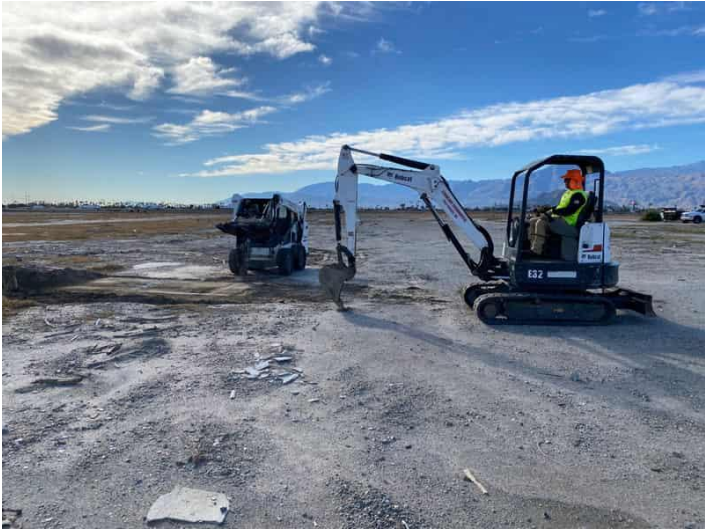
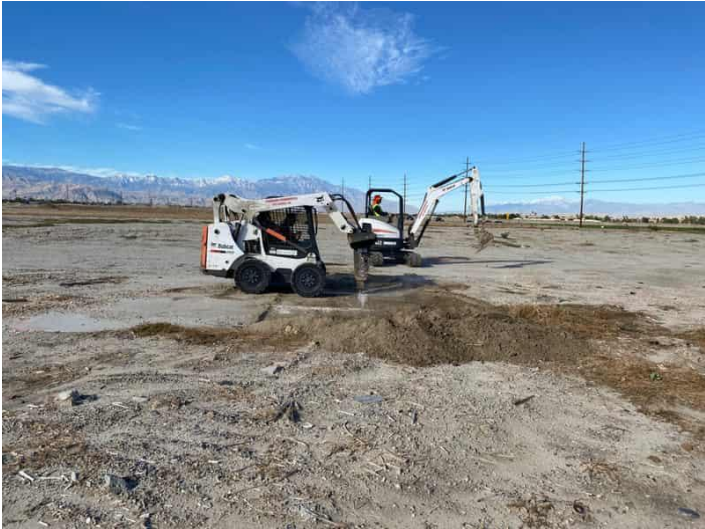
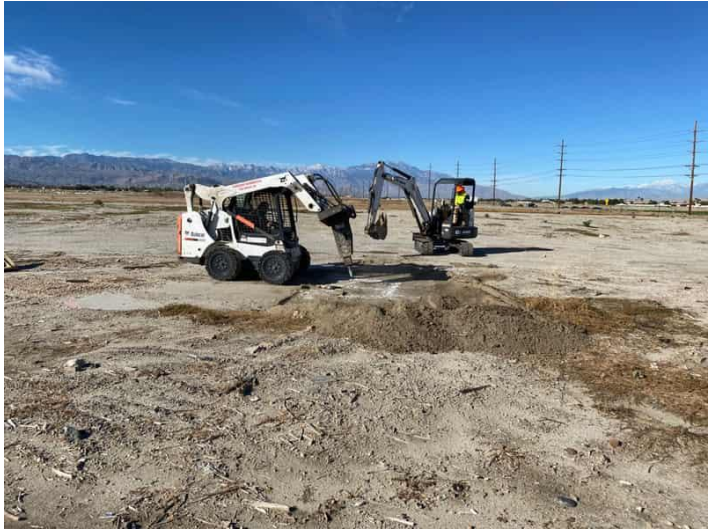
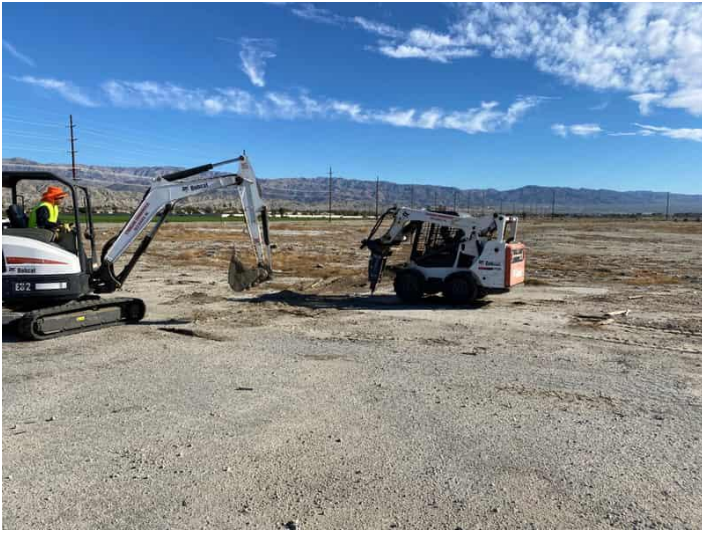
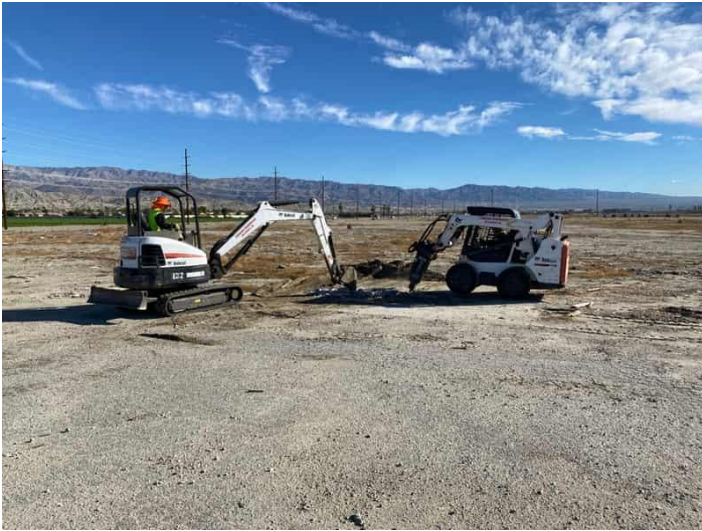
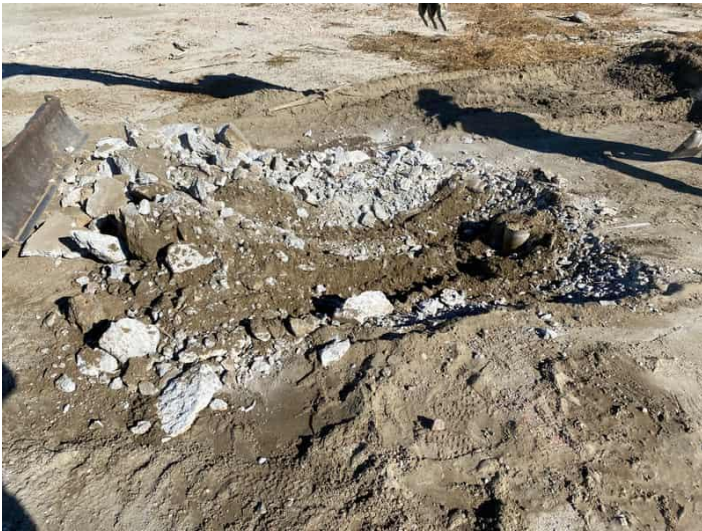
Photo Document of General On-Site Activities - 7. Anomaly Post-Excavation

Photo Description | Anomaly Site Excavation Activities

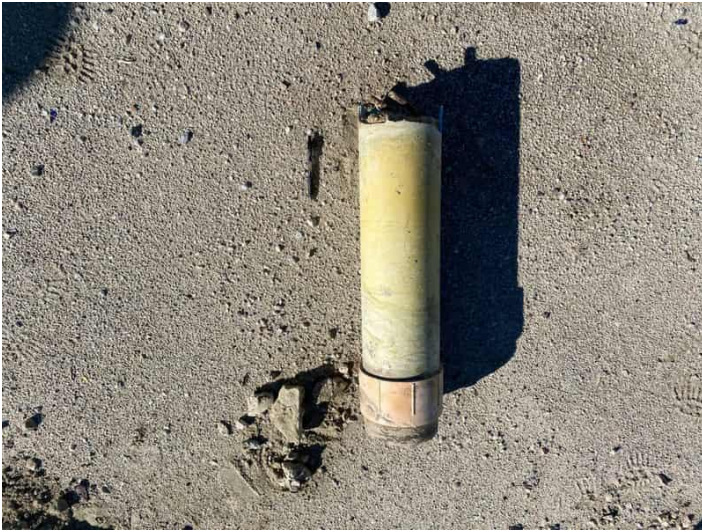
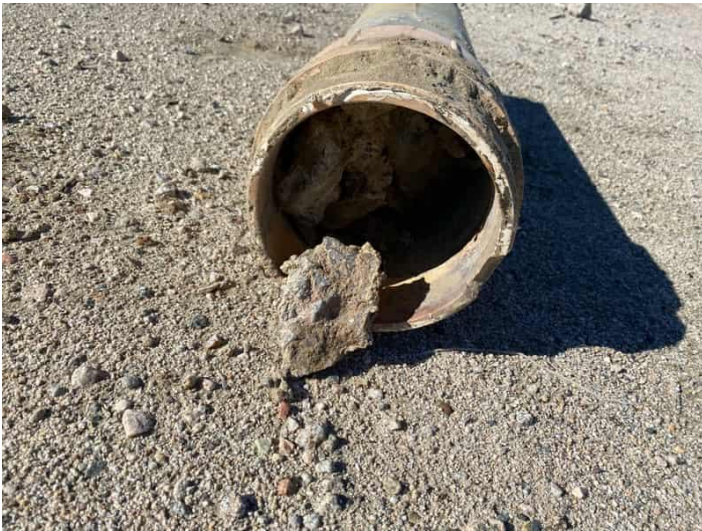
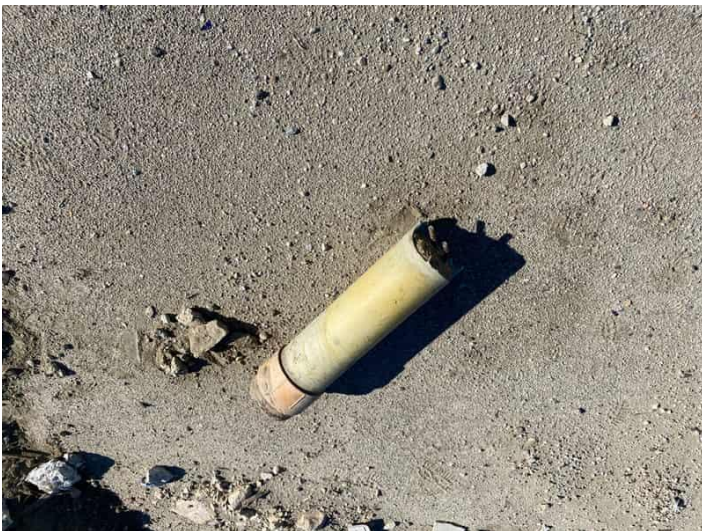
Anomaly Post-Excavation

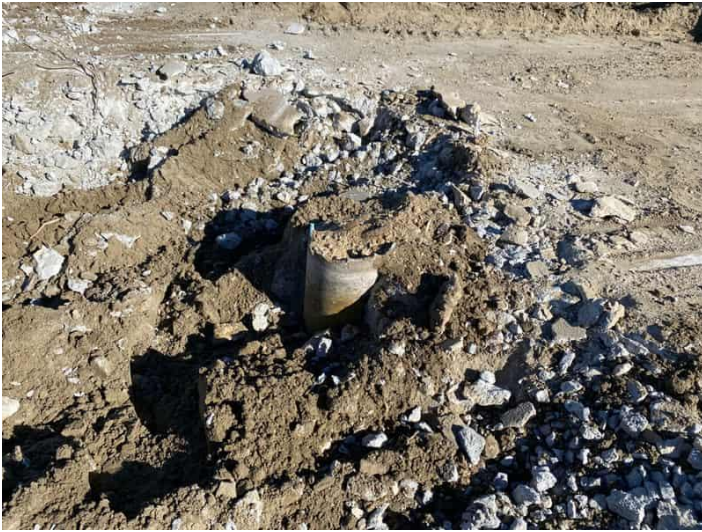
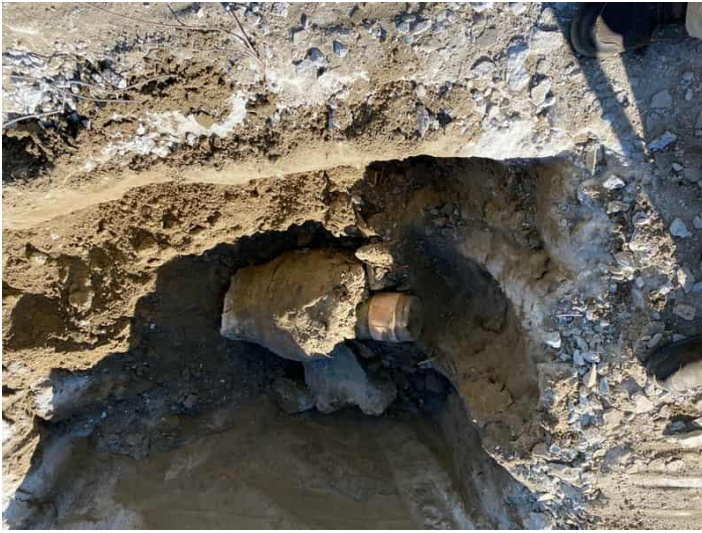
Photo Document of General On-Site Activities - 9. Anomaly Site Backfill and Compacting Activities

Anomaly discovered inside Excavation Pit

10:30 AM- The plastic pipe was removed from anomaly excavation pit. The plastic pipe was approximately 2-3 feet long and was filled with cement and rebar, encased in cement, and was found 1 foot > to 3 feet bgs.

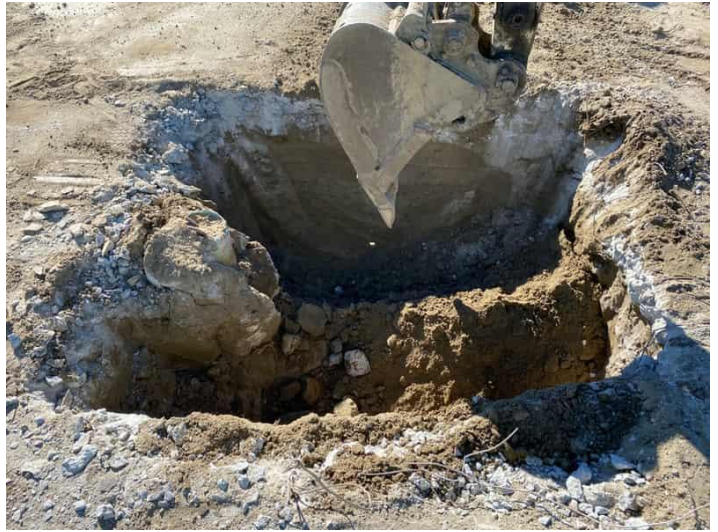
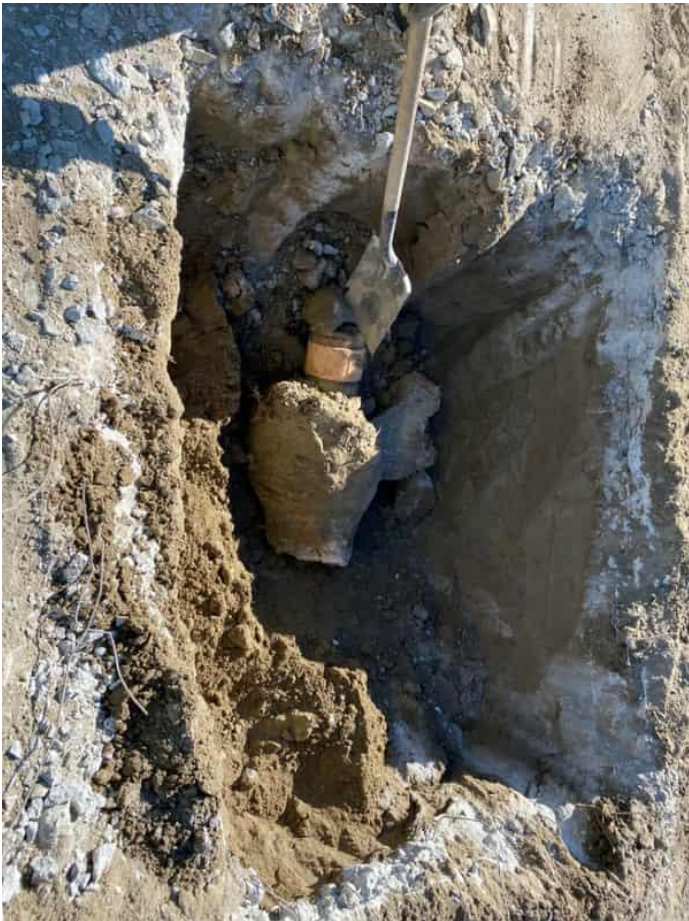
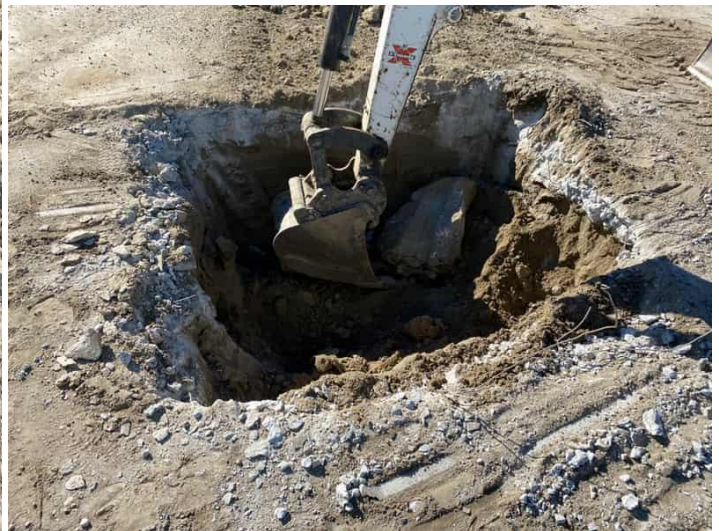
Photo Document of General On-Site Activities - 8. Anomaly discovered inside Excavation Pit

10:36 AM- PVC Power line was discovered on western boundary of the pit.
 10:42 AM- Strongarm began backfilling activities of the anomaly excavation pit.

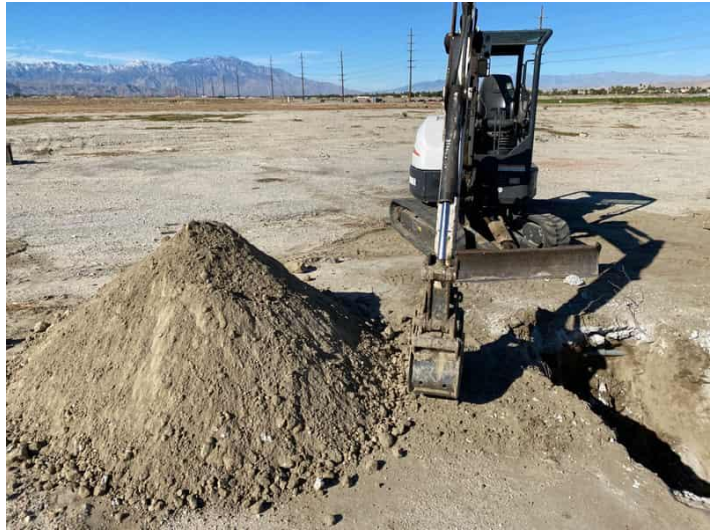
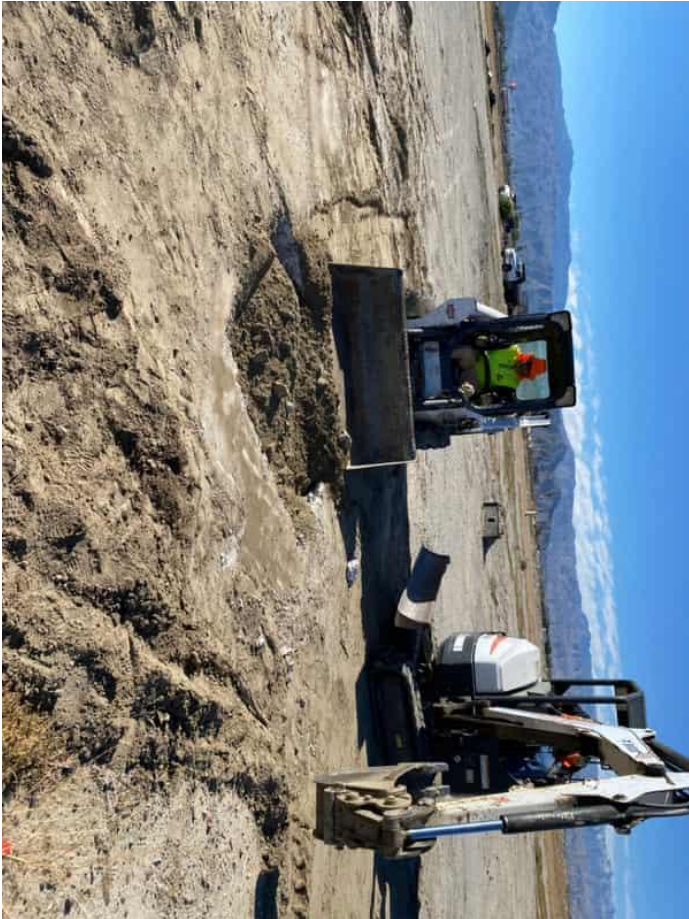
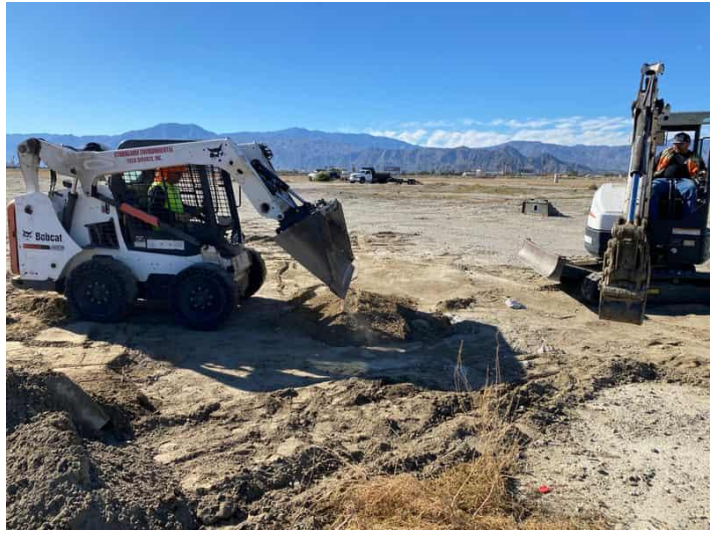
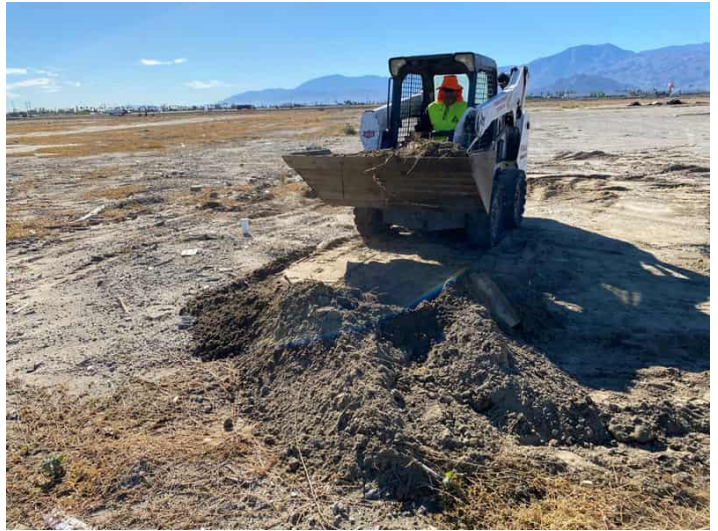
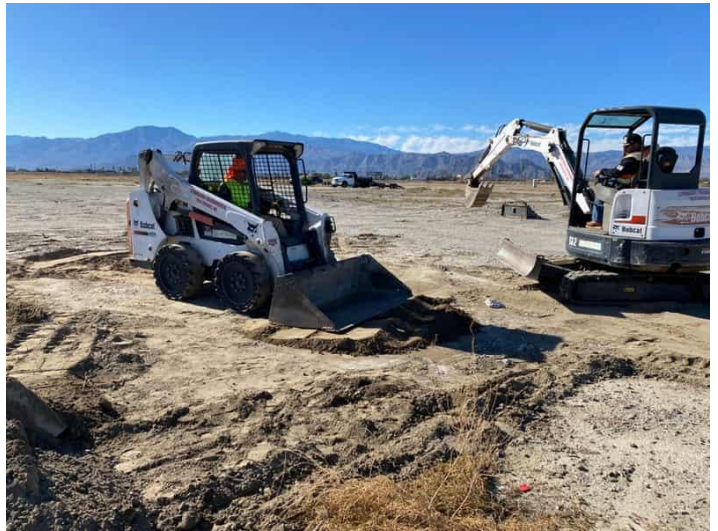
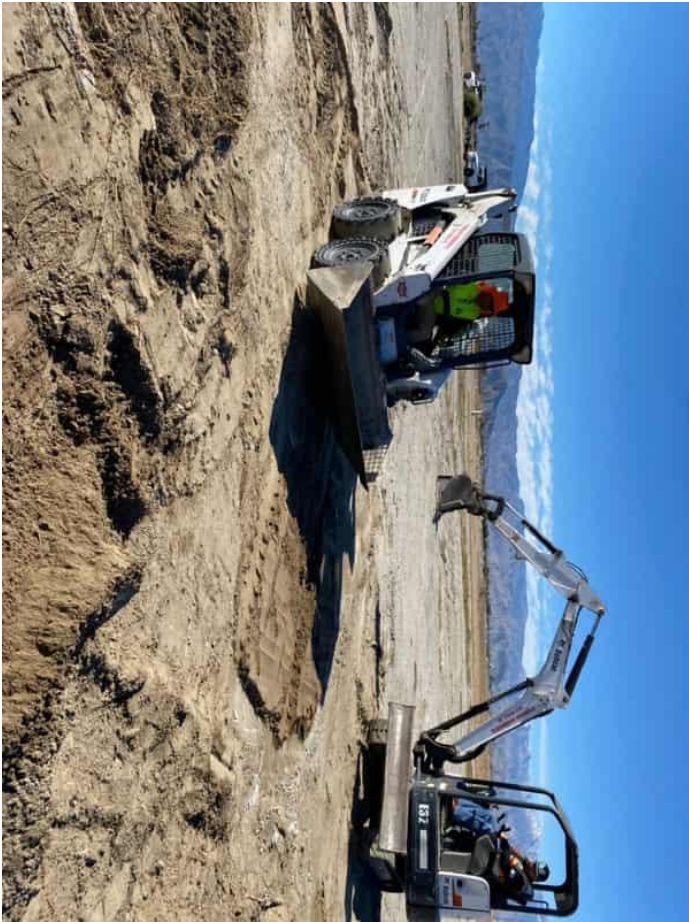
Anomaly Site Backfill and Compacting Activities
