Addendum to Phase I
Environmental Site
Assessment
Partner Engineering

**Subject: Addendum to Phase I Environmental Site Assessment
Vacant Land – Summary of Hydraulic Lift Removal Activities**
Southwest Corner of Monroe Street and 42nd Avenue
Indio, California 92203
Partner Project No. 22-388815.2

SUBSURFACE INVESTIGATION TO LOCATE UNDERGROUND UTILITIES

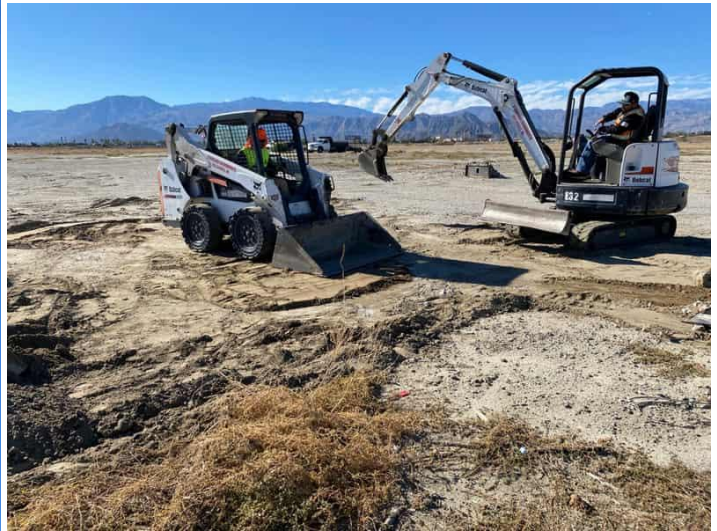
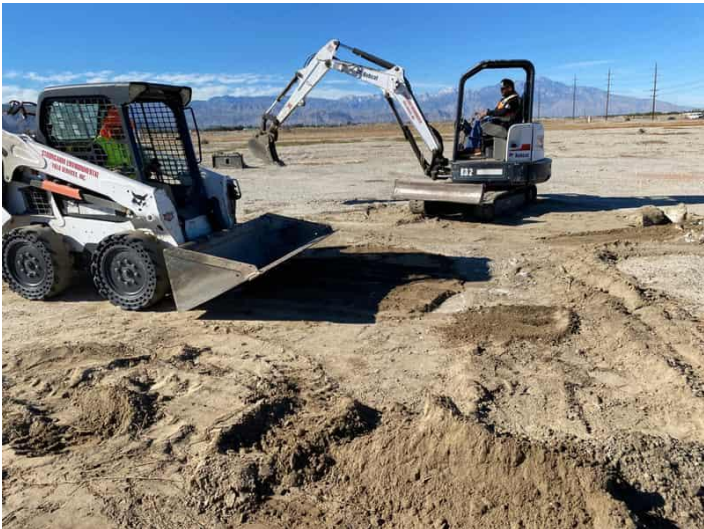
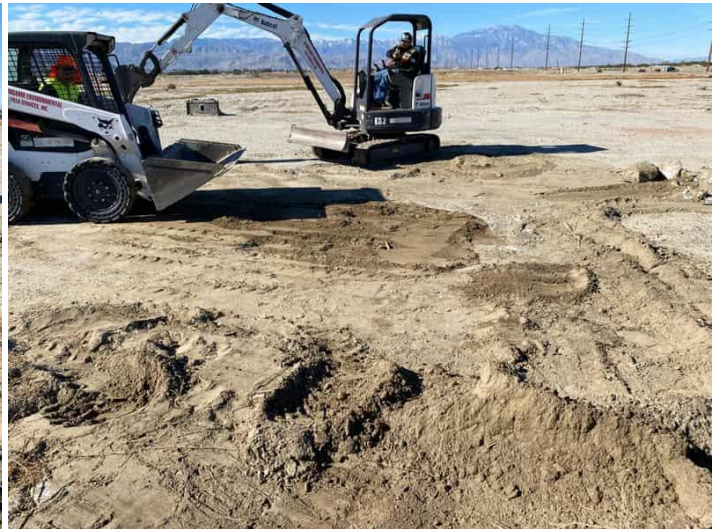
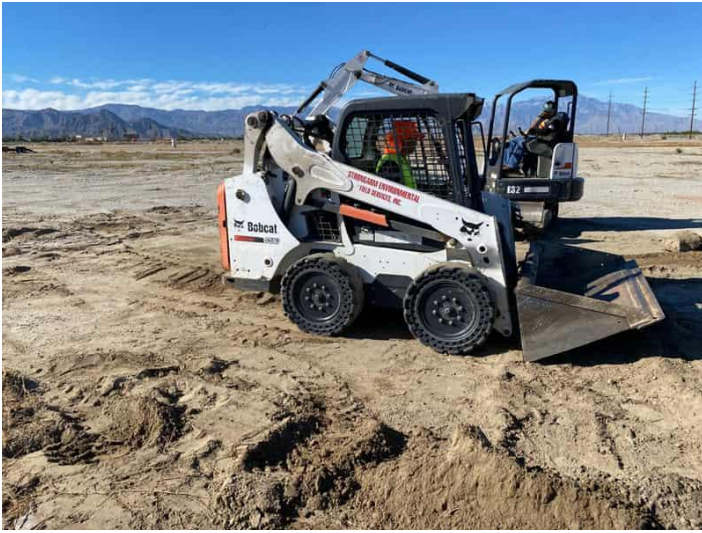
Anomaly Site Backfill and Compacting Activities

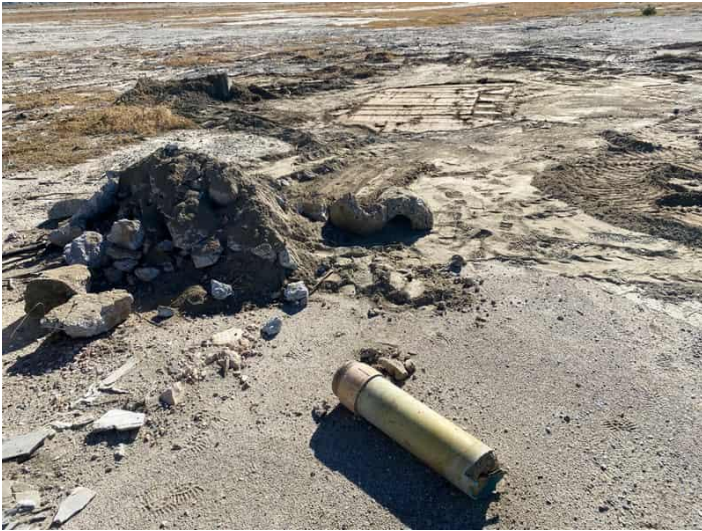
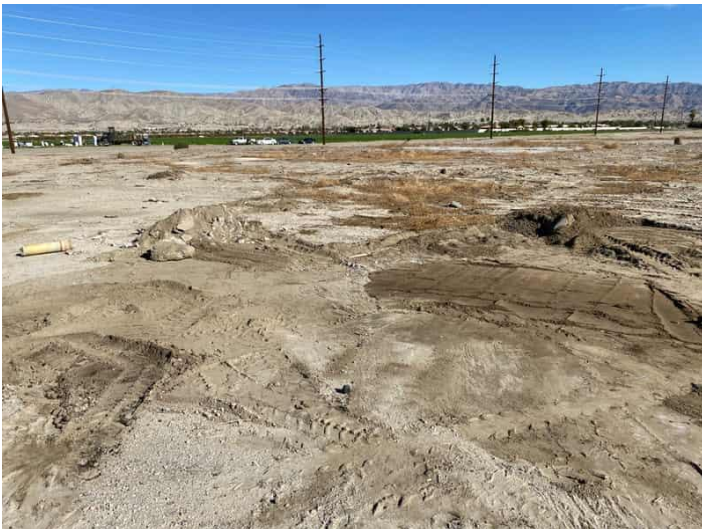
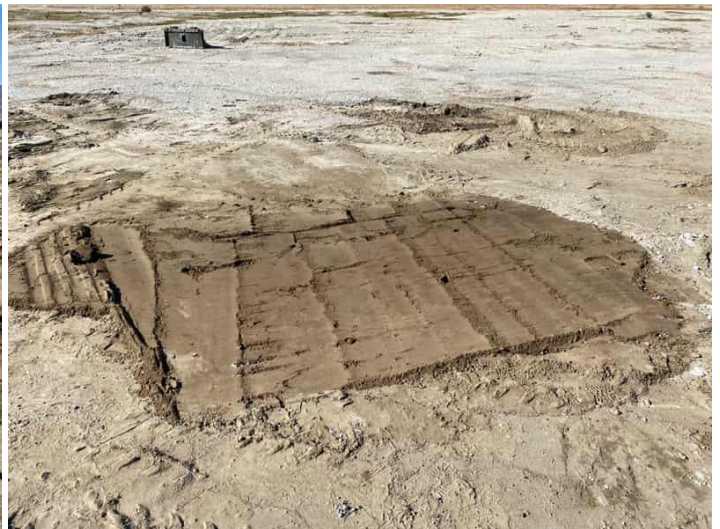
Photo Document of General On-Site Activities - 10. Anomaly Site Post-Backfill and Compacting Activities

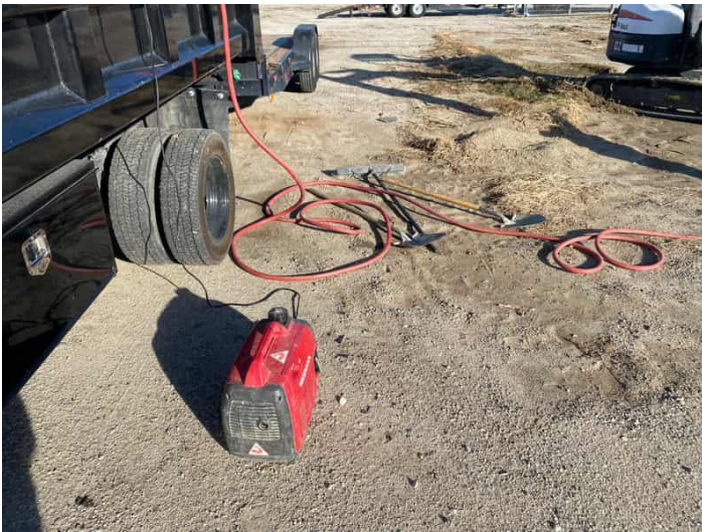
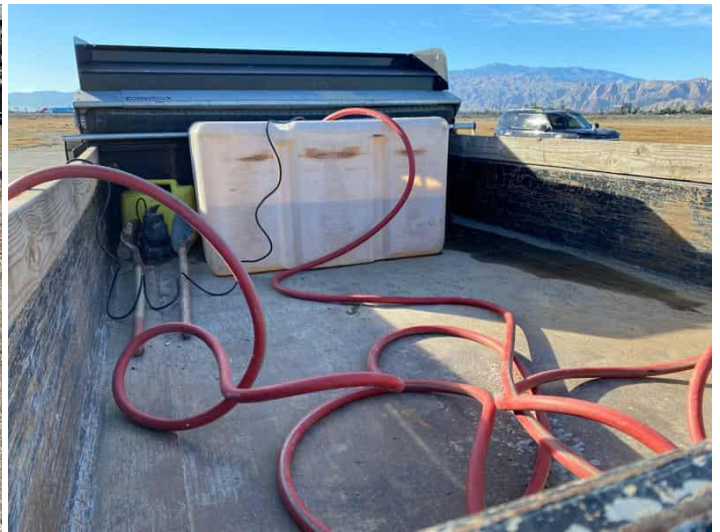
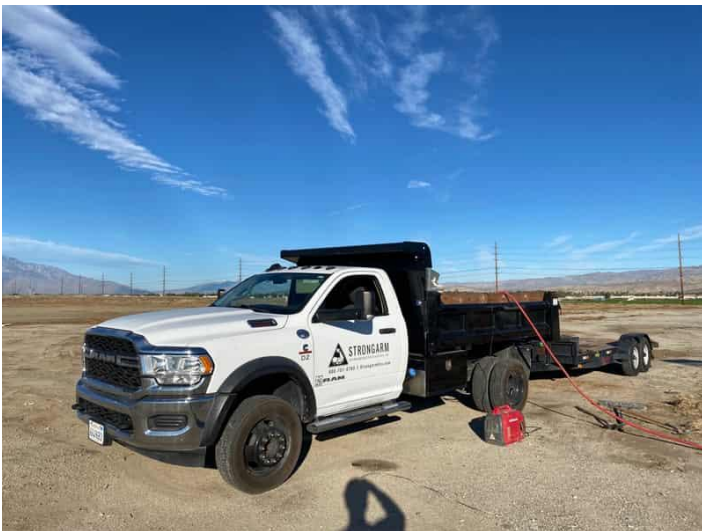
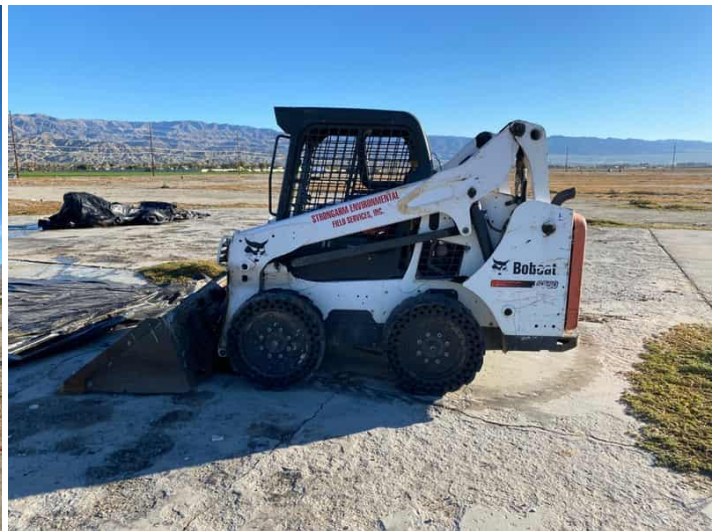
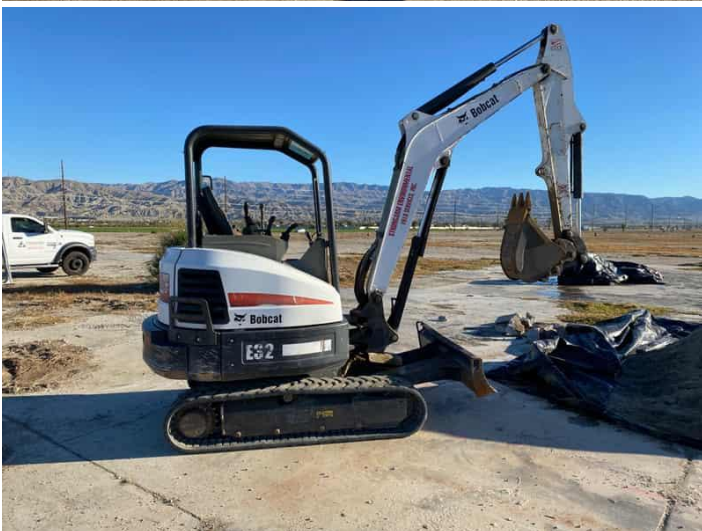
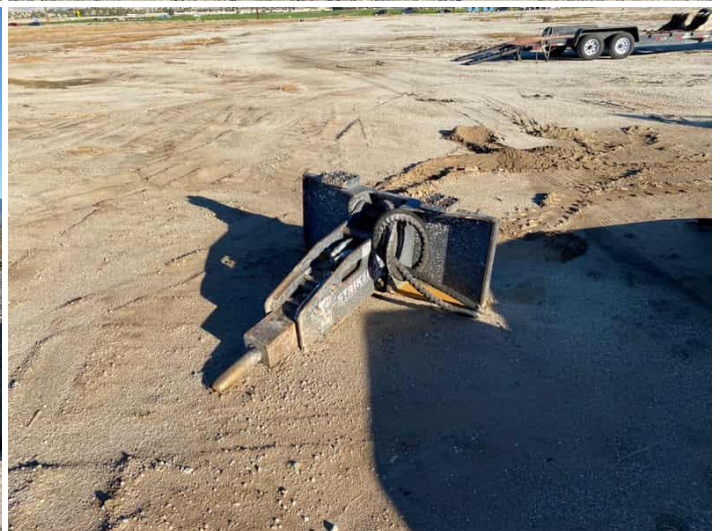
Photo Document of General On-Site Activities - 11. On-Site Field Equipment

On-Site Field Equipment
